EP 0250113

87-356825/51 A95 GENT 18.06.86
 GENERAL TIRE INC *EP -250-113-A
 18.06.86-US-875848 (23.12.87) B60c-11/24
 Tyre with tread wear indicating grooves - having various shallow
 depths adjacent opposite shoulders
 C87-152686 R(BE DE ES FR GB IT LU NL)

54 Tire with tread wear indicating grooves.

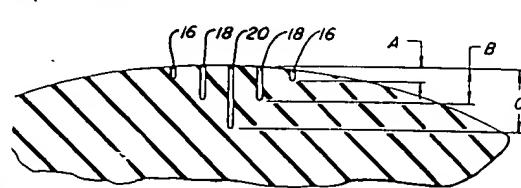
FIG. 4

Each gp. of shallow grooves includes three grooves of three different depths, the shallowest groove being 0.02-0.07 in. deep, the intermediate groove being 2-3 times deeper than the shallowest groove, and the deepest groove being 1½-2½ times deeper than the intermediate groove. Most pref., the shallowest groove is 0.03 in. deep, the intermediate groove 0.09 in. deep, and the deepest groove 0.16 in. deep, i.e., the three grooves have depths in the ratio 1 : 3 : 5.

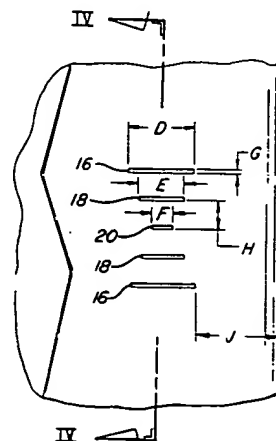
FIG. 3

Most pref., there are five parallel grooves in each gp., the first and last grooves being the same depth and the shallowest, the next adjacent grooves being intermediate grooves of the same depth, and the centre groove being the deepest. Addnl. gps. of shallow grooves are located adjacent each shoulder at equally spaced intervals around the circumference of the tyre. (11pp466MJDwgNo1/8).

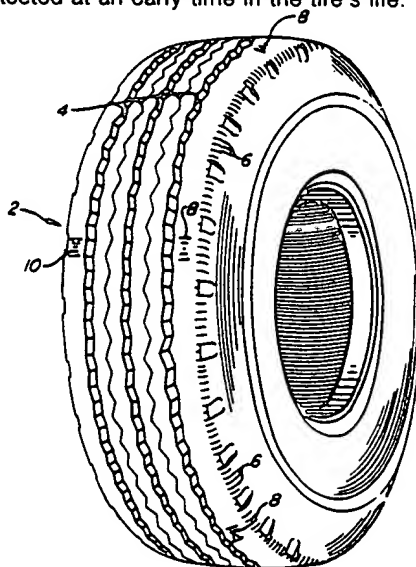
FIG. 1

57 In order to detect early uneven wear patterns on new tires resulting from vehicle misalignment, the treads of the tires are provided with groups (8,10) of grooves of varying depths, so that the grooves will wear away at varying rates. Preferably a group (8,10) of at least five grooves is provided on the outermost ribs of the tire adjacent each shoulder (6) and at the same circumferential position. Also, the grooves (8,10) are preferably made of different lengths corresponding to their depths for easy identification. By observing how fast the grooves of one group on one shoulder rib wear away relative to the grooves on the other shoulder rib, uneven wear of the shoulder ribs can be detected at an early time in the tire's life.

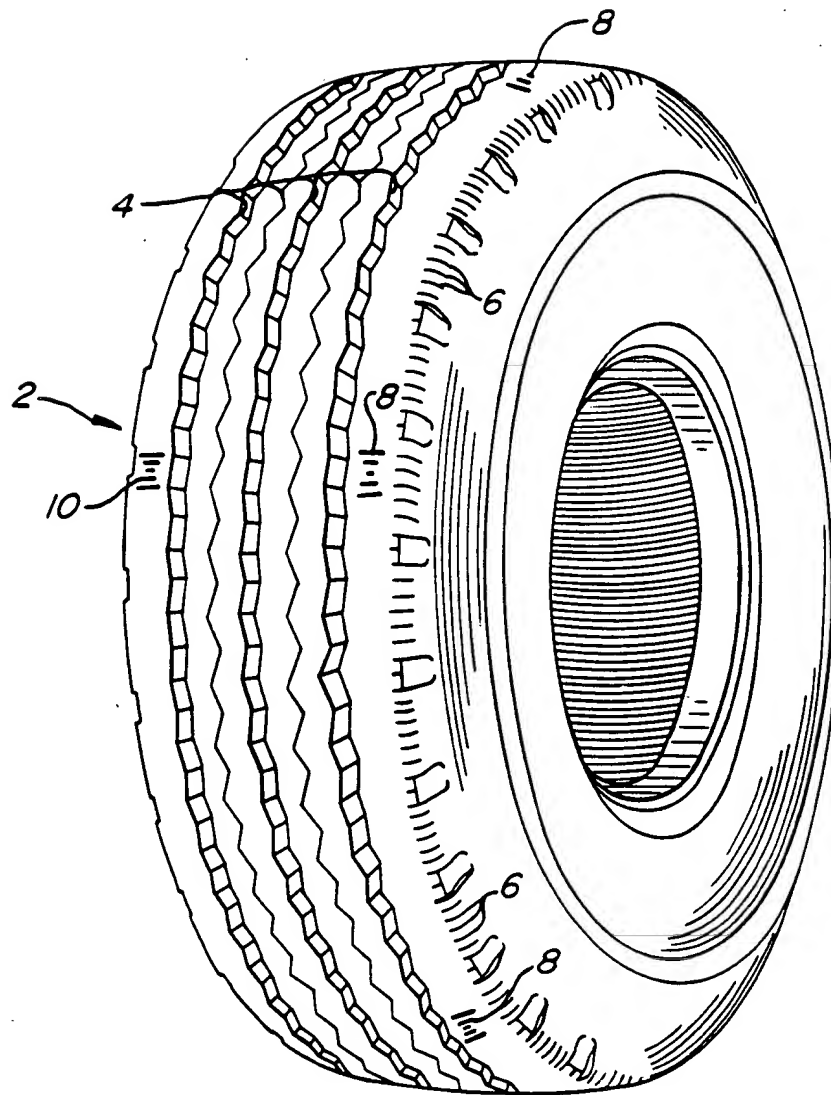
FIG. 1

Figure 1 is a perspective view of a tire illustrating one embodiment of the present invention;
 Figure 2 is a perspective view of a tire illustrating a second embodiment of the present invention;
 Figure 3 is an enlarged view of a portion of the tire of Figure 1;
 Figure 4 is a sectional view of the tire of Figure 1 taken along lines IV-IV of Figure 3;
 Figures 5 through 8 are front-end views of a vehicle having tires embodying the subject invention.
 In Figure 1, a vehicle tire 2 has circumferential grooves 4 provided for traction purposes. Small grooves 6 on the shoulders of the tire give the tire improved stability and shoulder wear.
 The improvement that is the subject of this invention resides in groups of small laterally extending grooves 8 and 10 that are located in the tire of Figure 1 adjacent the shoulders. Preferably, there are four groups of grooves 8 and four groups of grooves 10 adjacent each shoulder and spaced evenly around the circumference of the tire at 90 degree intervals. The number and spacing of the groups and grooves 8 and 10 around the circumference of the tire may vary depending on the amount of circumferential variation in tread wear that is expected. However, in order to obtain an accurate indication of the relative difference in tread wear between the shoulders of the tire, each group of grooves 10 should be located laterally opposite from and at the same circumferential location as one of the groups of grooves 8. This will allow the tread wear on the shoulder ribs to be compared at the same circumferential locations.

Of course, the tread-wear indicating grooves do not have to be located on the tire at the same locations as the groups of grooves 8 and 10 shown in Figure 1. The grooves may be located anywhere on the tread where it is desired to measure tread wear and to compare that wear with the wear at some other location on the tire. For instance, it may be desirable to compare the wear on the shoulder rib of the tire with the wear in the center of the tread. In that event, groups of tread-wear indicating grooves would be located as shown by the groups of grooves 12 and 14 on the tire 2' in Figure 2.

To prevent the groups of grooves 8 and 10 from interfering with the shoulder wear or control characteristics of the tire, the grooves should be spaced from the shoulder of the tire so that the widest groove is no closer than a distance ("J") of 0.3 inches (7.6 mm) from the shoulder edge. Of course, both groups of grooves 8 and 10 should be placed the same distances from their respective shoulders, so that the areas measured for wear give a comparable indication of the degree to which the tread is wearing on each side of the tire.

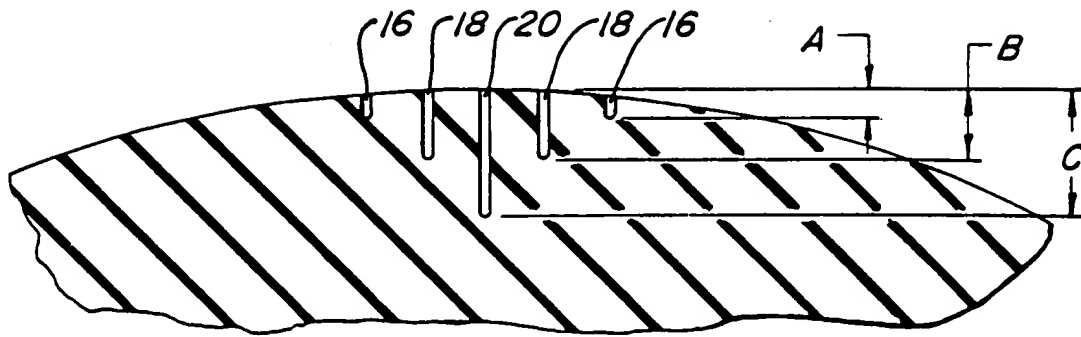
FIG. 4

Figures 3 and 4 show a typical group of tread-wear indicating grooves 8 in detail. The group of grooves 8 includes two long and shallow grooves 16 at either end of the group, two grooves 18 of the intermediate length and depth, and a central groove 20 that is short but relatively deep.

A recommended width "G" of the grooves 16, 18, and 20 (Figure 3) is 0.03 inches (0.8 mm), and a recommended spacing "H" of these grooves is 0.2 inches (5.1 mm). A typical set of recommended groove depths would be, referring to Figure 4, a depth "A" of grooves 16 of 0.03 inches (0.8 mm), a depth "B" of grooves 18 of 0.09 inches (2.3 mm) and a depth "C" of groove 20 of 0.16 inches (4.1 mm). The ratio of these groove depths is approximately 1:3:5.

Preferably the ratio of the intermediate groove 18 has a depth between two and three times the depth of the shallowest groove 16 and the deepest groove 20 has a depth between one and a half and two and a half times the depth of the intermediate groove 18. These depth relationships insure that the grooves wear away at separate intervals of tread wear so that the grooves remaining provide a good indication of the relative amount of wear that has occurred in the area of the tread where the group of grooves 8 is located.

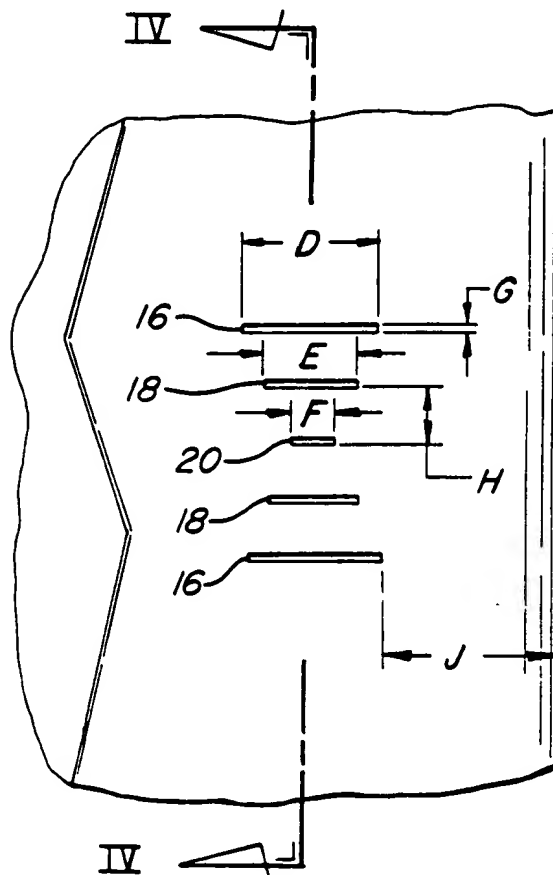
FIG. 3

For ease of identification of the grooves 16, 18 and 20, they are preferably made of different lengths, for instance a recommended length "D" of grooves 16 is 0.5 inches (12.3mm), a recommended length "E" of grooves 18 is 0.35 inches (8.9 mm) and a recommended length "F" of groove 20 is 0.2 inches (5.1 mm).

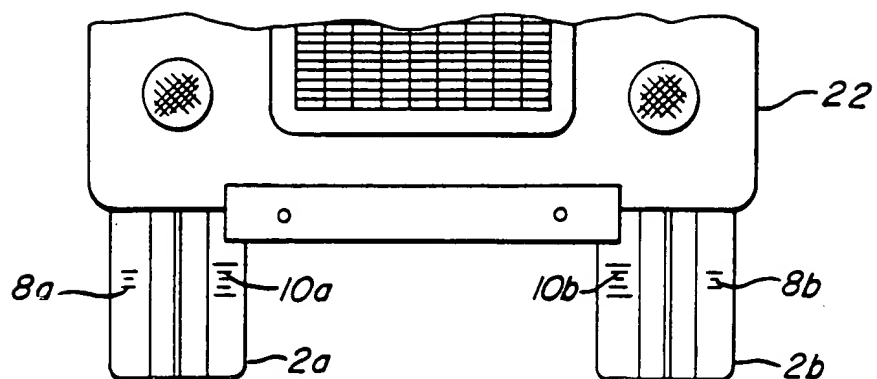
FIG. 5

In Figure 5, the tread area around the groups of shallow grooves 8a and 8b on the outside ribs of the tires 2a and 2b has been worn to a point where the longest and shallowest grooves have been completely worn away. On the other hand the groups of shallow grooves 10a and 10b on the inside ribs of the tires 2a and 2b have still retained all five grooves, indicating less tread wear on these inside ribs. The condition of the tread wear on the tires 2a and 2b thus indicates the front end alignment of the vehicle 22 should be checked for excessive toe-in.

Figures 5 through 8 show how early uneven tread wear can be detected on the shoulder ribs of tires, when the tires are provided with groups of grooves such as the groups 8 and 10 of the tire of Figure 1. In fact, it is often possible to identify the probable cause of such uneven tread wear, so that the problem can be corrected very early in the tire's life, for instance in the first 3,000 to 10,000 miles of wear of a highway vehicle tire.

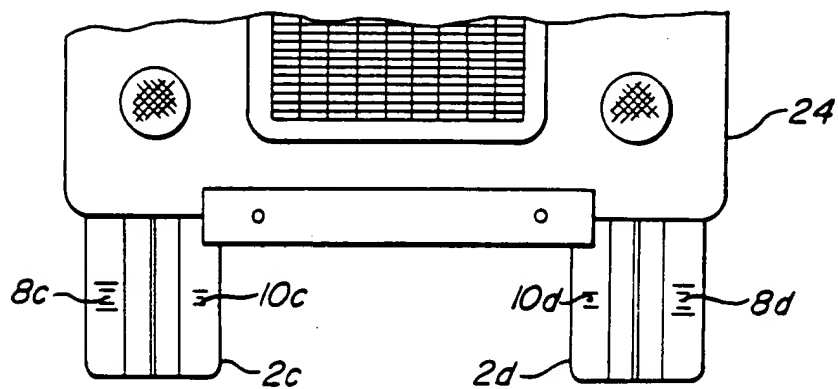
FIG. 6

In Figure 6, the tires 2c and 2d have groups of shallow grooves 10a and 10b that have been reduced to just three grooves, while the groups 8a and 8b have all five grooves remaining. This indicates the inside ribs of both tires are wearing faster than the outside ribs, and an excessive toe-out in the alignment of vehicle 24 may be the problem.

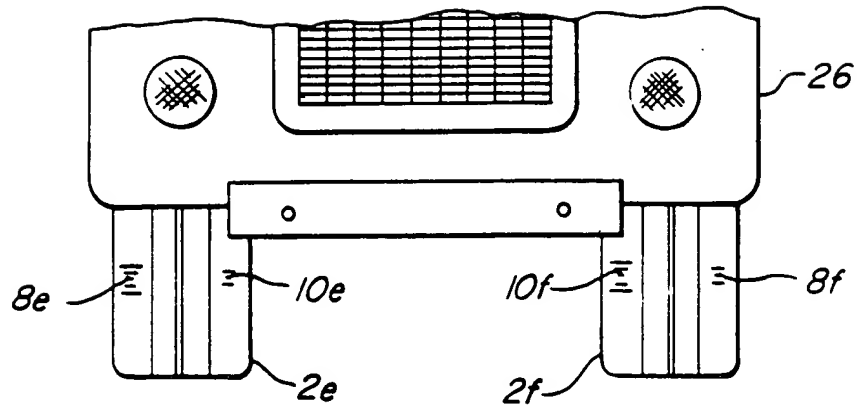
FIG. 7

In Figure 7, the groups of grooves 10e on the inside of tire 2e and the group of grooves 8f on the outside of rib of tire 2f have been reduced to three grooves, while the groups of grooves 8e and 10f on their respective tires still have all five grooves. This indicates excessive tread wear on the left sides of both tires (from the driver's viewpoint), possibly caused by the rear axle or axles of the vehicle 26 not being perpendicular to the vehicle frame and pushing it to the left.

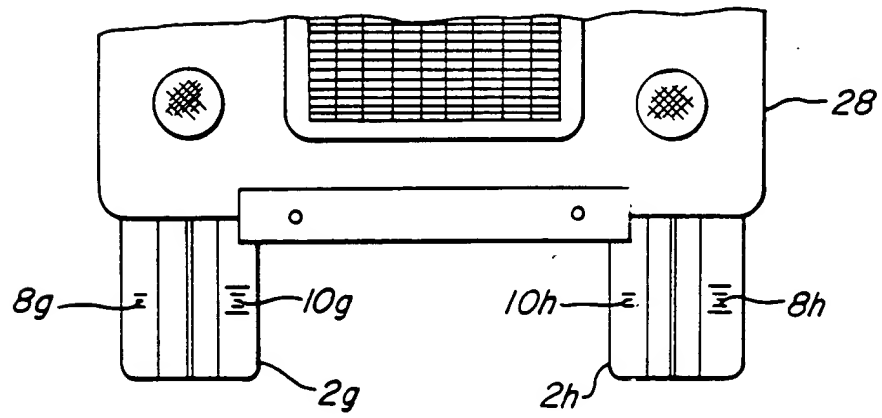
FIG. 8

In Figure 8, the opposite problem from that illustrated in Figure 7 appears to be the case. Groups of grooves 8g and 10h on the right-hand sides of their respective tires (from the driver's viewpoint) have been reduced to three grooves because of excessive tread wear. Possibly the rear axles of the vehicle 28 are pushing it to the right.
